EXHIBIT “A-2”

Electrolux / General Electric Design

The subject dryer designs employed by Electrolux in their 5.7/5.8 Cu. Ft. dryers were evaluated and the following hazards related to the risk of fire were identified:

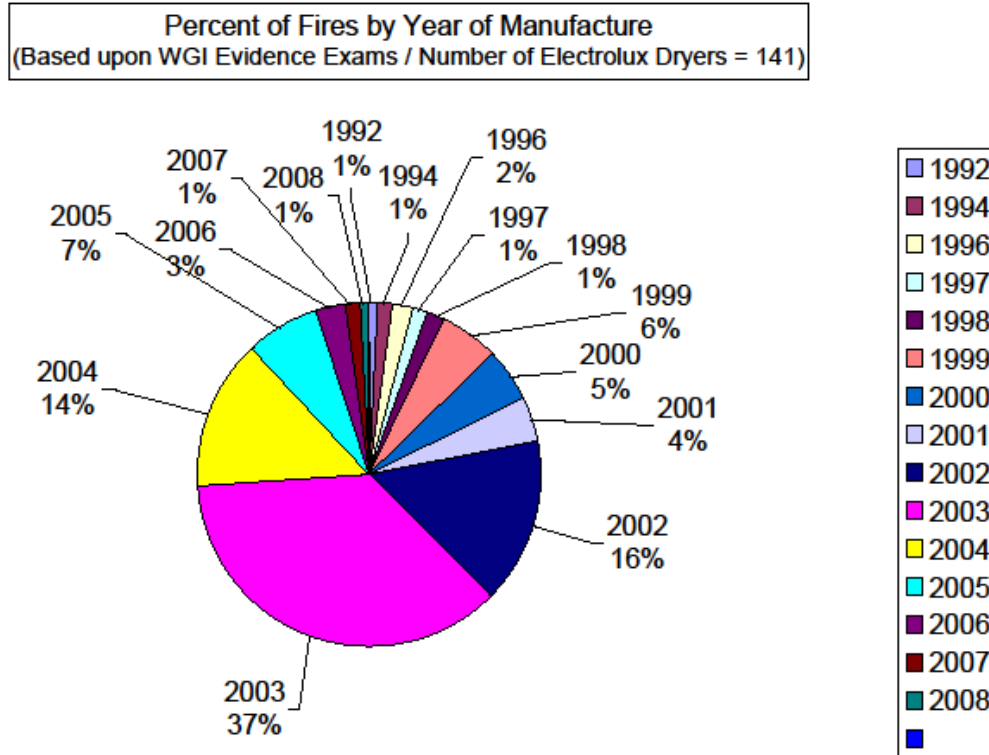
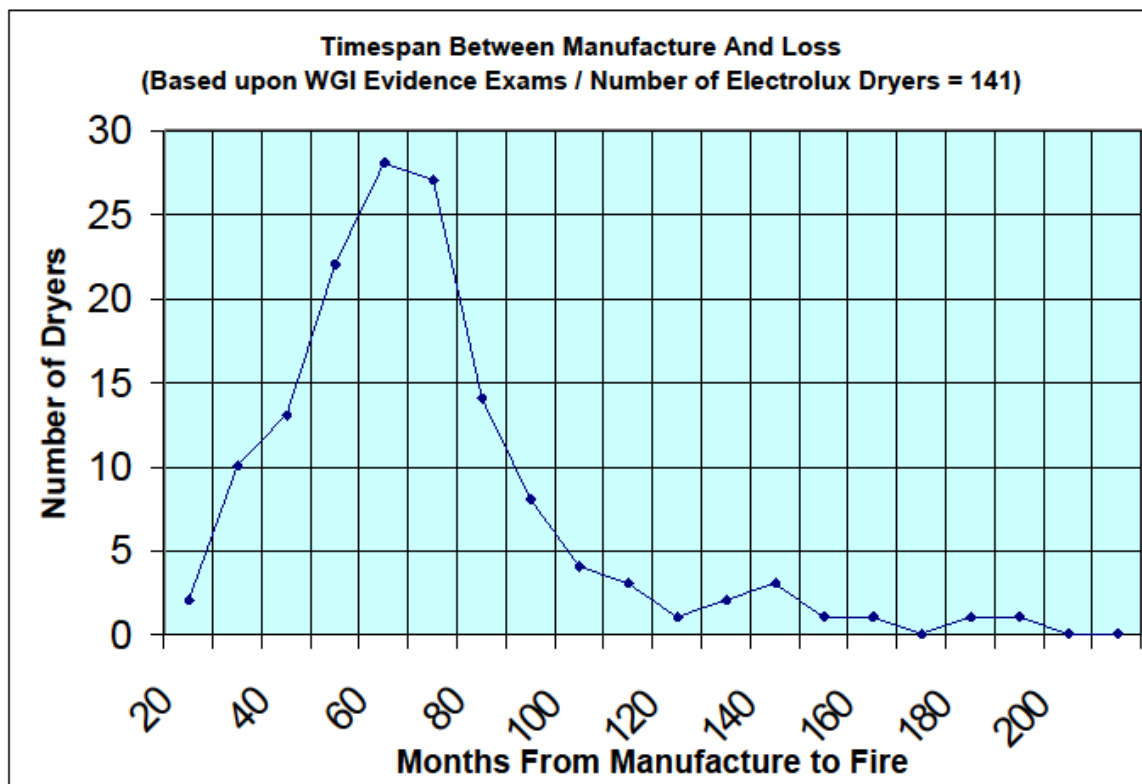
Statistical data was also compiled using these burned Electrolux dryers. For a group of 141 Electrolux dryers involved in fires (both gas and electric models), the following charts outline the percentage of fires based upon the year the dryer was manufactured and the time span, in months, between the date of manufacture and the date of the fire. The greatest frequency of fires occurred in a general range from 3 to 6.5 years, with the highest number of fires occurring approximately 5 years after the date the dryer was manufactured. The greatest percentage of dryers based upon the year of manufacture occurred after Electrolux altered the felt front seal. Similar statistical analysis has been conducted by some of our peers, including Fire Findings

Investigations and the Traveler's Insurance Laboratories. Their findings were substantially similar to the Wright Group's statistical analysis. It should be noted that this statistical data was compiled in May of 2010, using data collected from Electrolux dryers we examined from 2007-2009. The 141 dryers cited in this study currently represent only a small fraction of the several hundred Electrolux dryer cases we have been involved in, yet the average age of these dryers consistent at approximately 5 years of age when they experience fires.

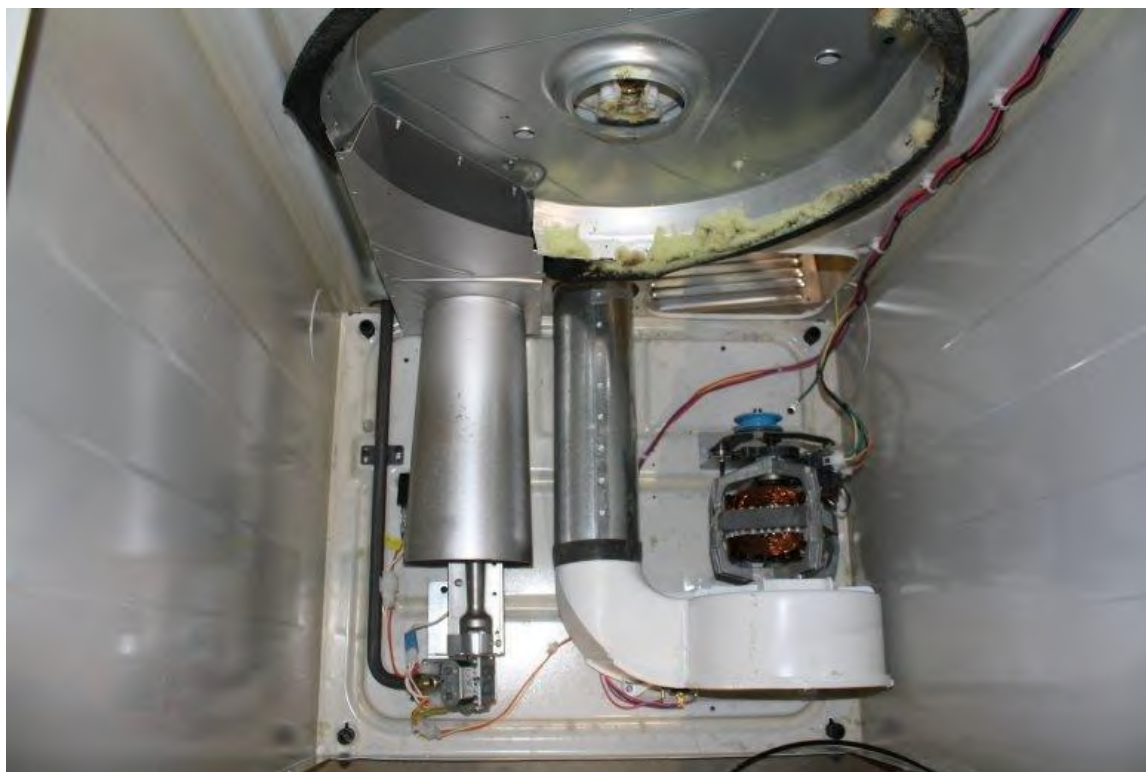
Based upon this testing, it has been demonstrated that the ball-hitch design, used by Electrolux in their dryers, operated without a baffle and with an exhaust system back pressure of less than 0.75 inches of water column (specified in Electrolux's Installation Instructions as "acceptable") accumulate significant amounts of lint in between the heat source and the drum after only twenty loads of ten bath towels were washed and dried. The used Electrolux ball-hitch dryer collected even more lint, and a lint ignition fire occurred during the test. The RONCO 3 alternative still collected lint in the heater pan, but the guard prevented the lint from entering the heat duct and igniting. In contrast, the bulkhead design used by Whirlpool, Maytag, LG, Samsung and now Electrolux, was tested using the same parameters did not accumulate any lint in the path of airflow between the heat source and the drum.

Photo 4: New Electrolux Dryer – Cabinet and Heater Pan after Testing

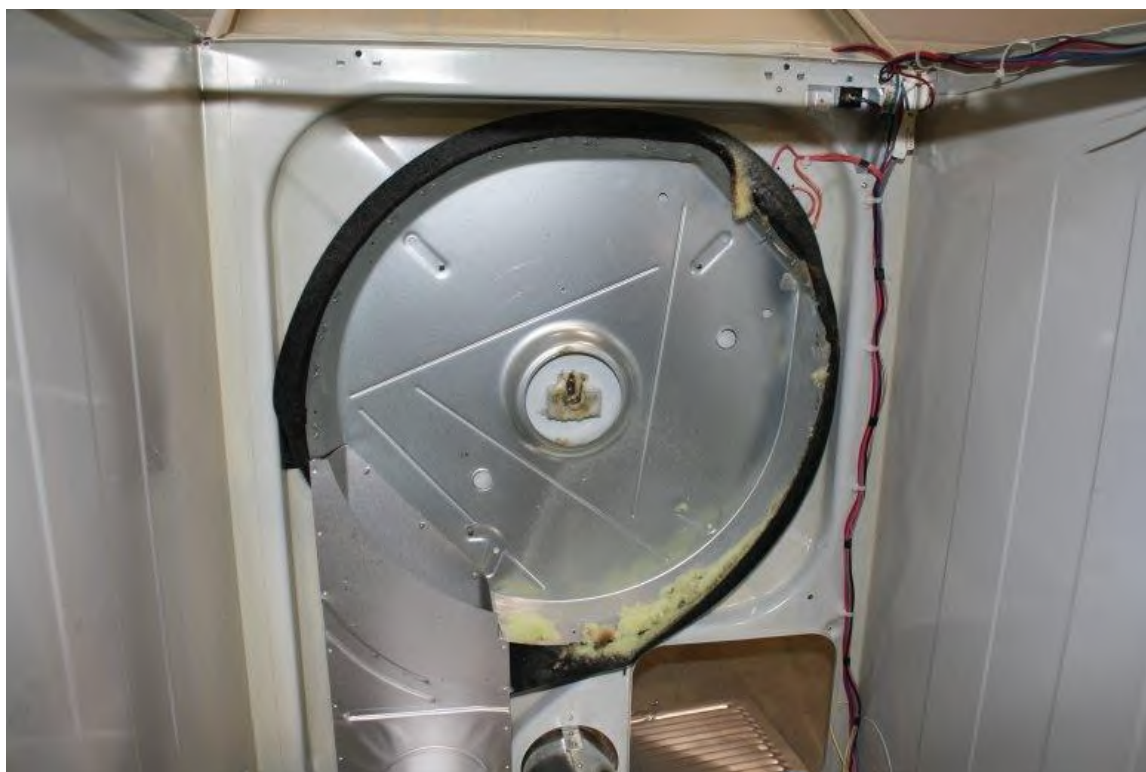
Photo 5: New Electrolux Dryer - Heater Pan after Testing

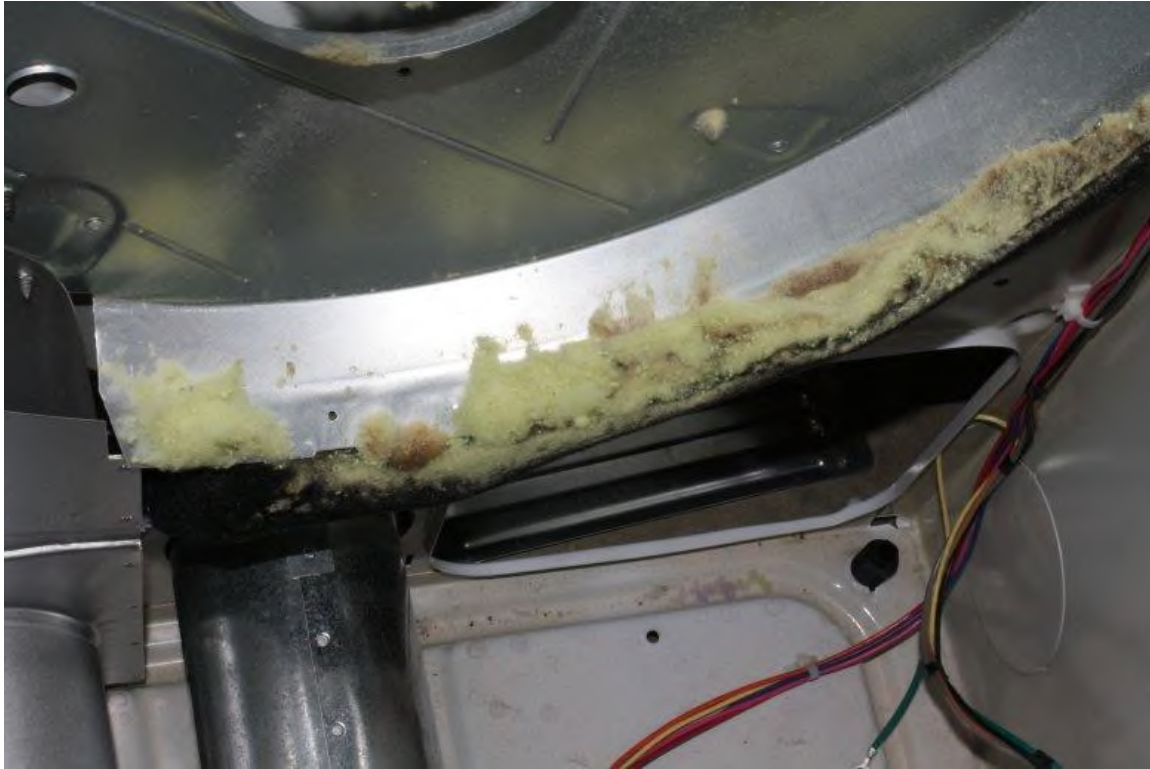
Photo 6: New Electrolux Dryer – Lint in Heater Pan after Testing

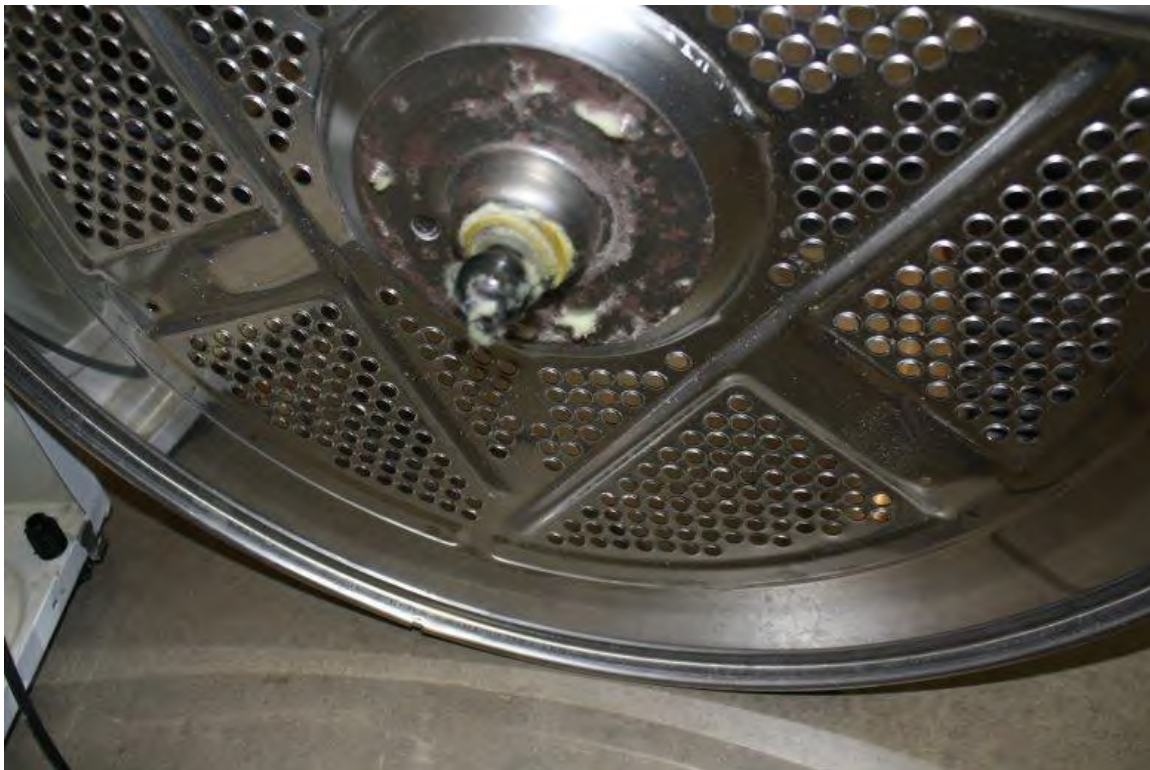
Photo 7: New Electrolux Dryer – Rear of Drum after Testing

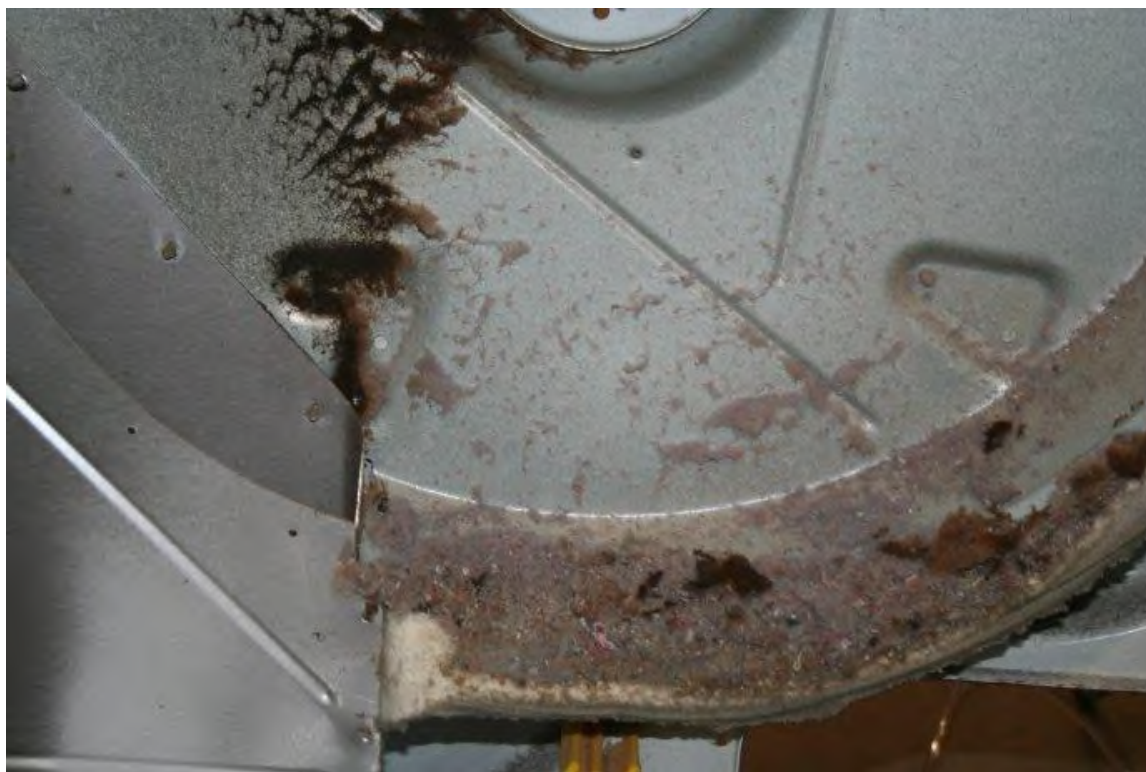
Photo 10: Used Electrolux Dryer – Lint in Heater Pan before Testing

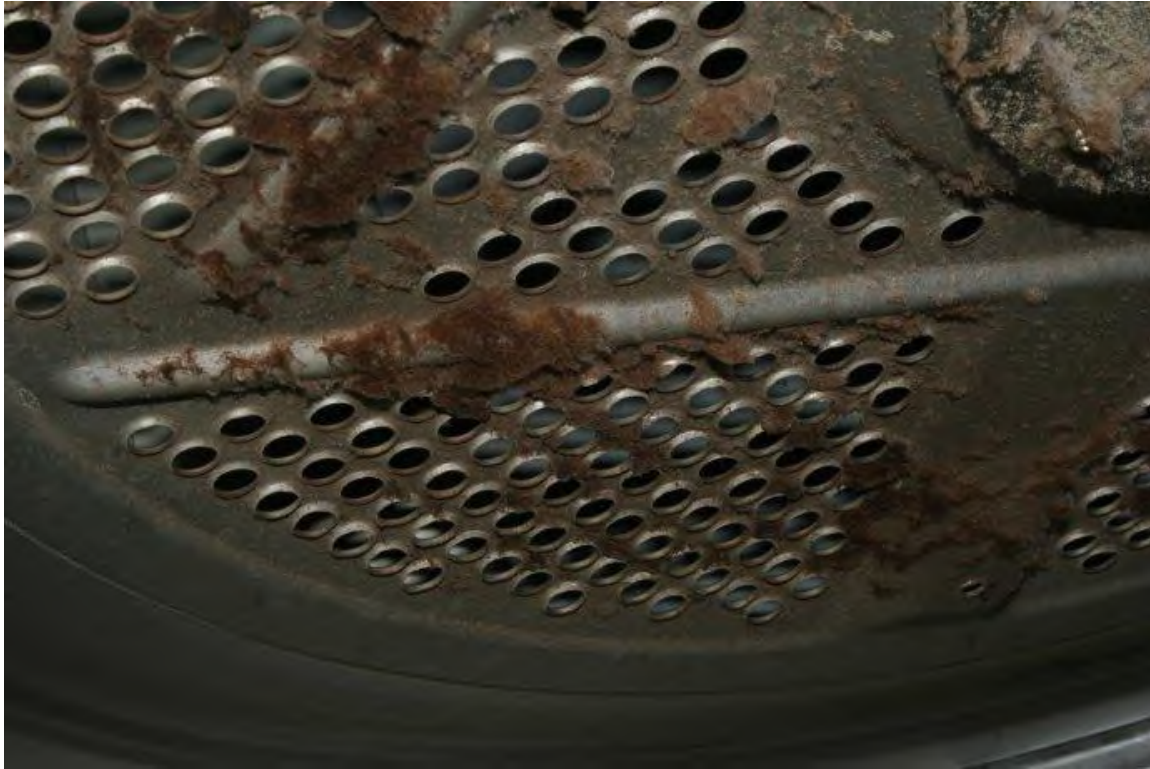
Photo 12: Used Electrolux Dryer – Lint on Rear of Drum before Testing

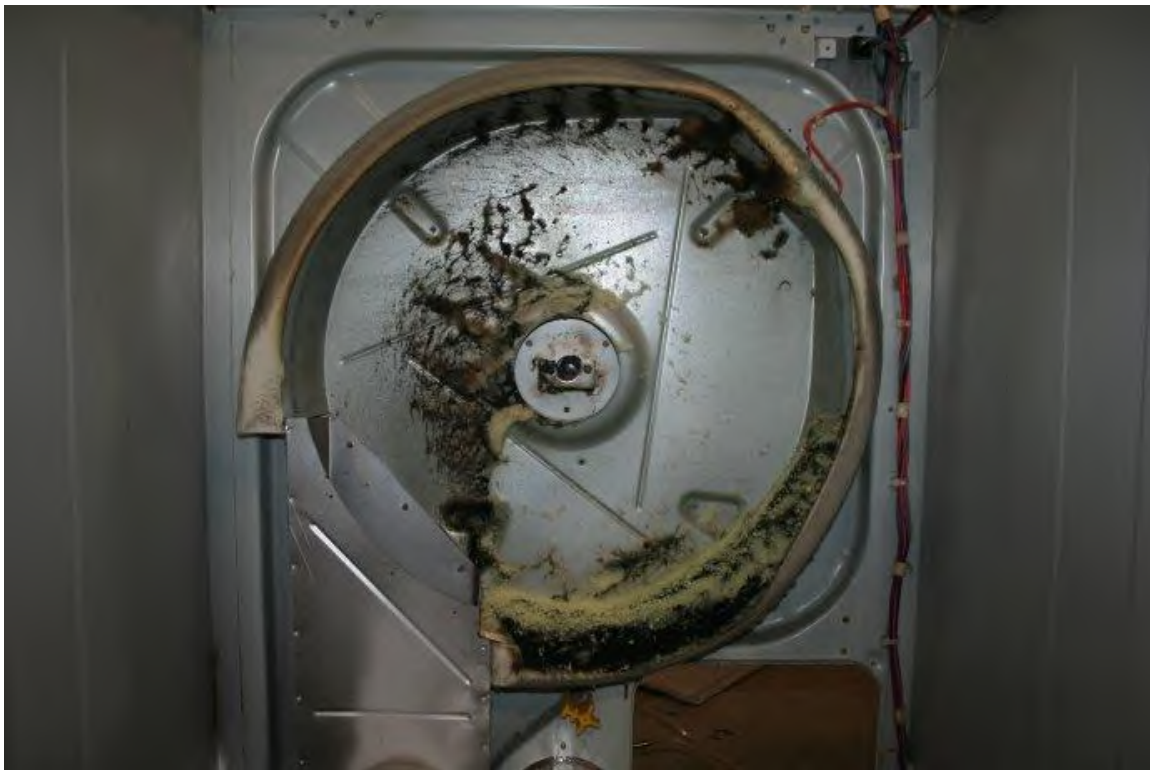
Photo 13: Used Electrolux Dryer – Heater Pan Testing

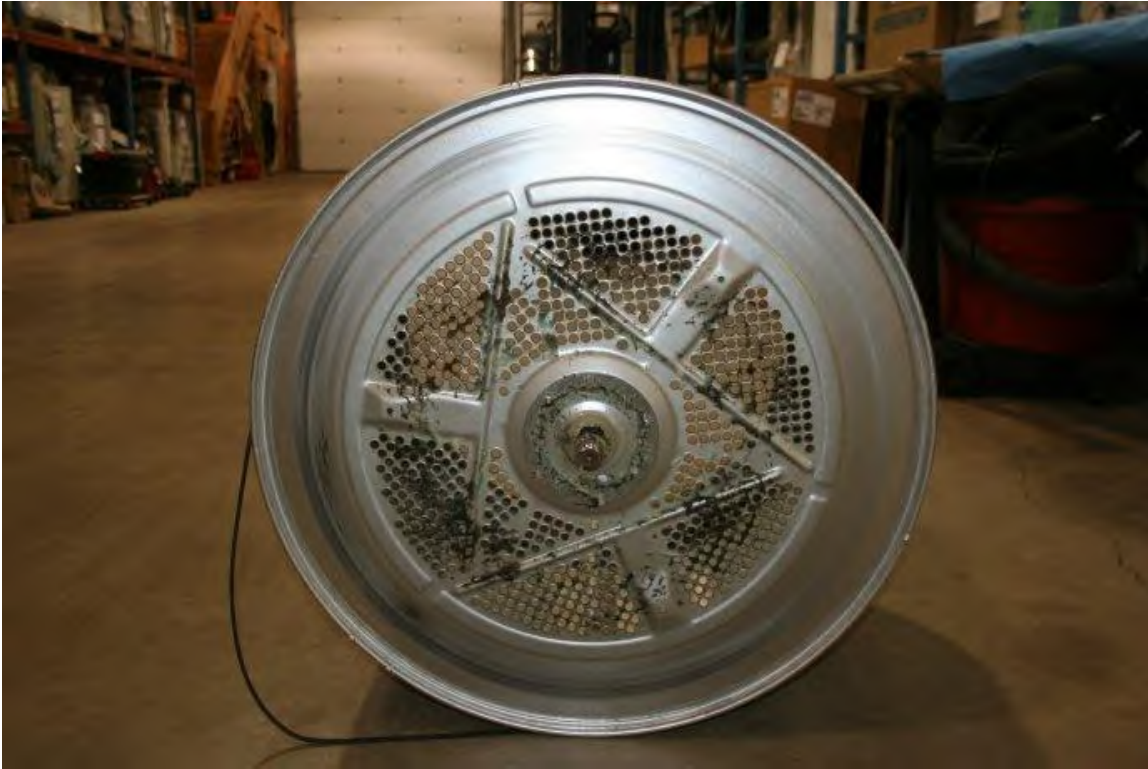
Photo 16: Used Electrolux Dryer – Rear of Drum after Testing

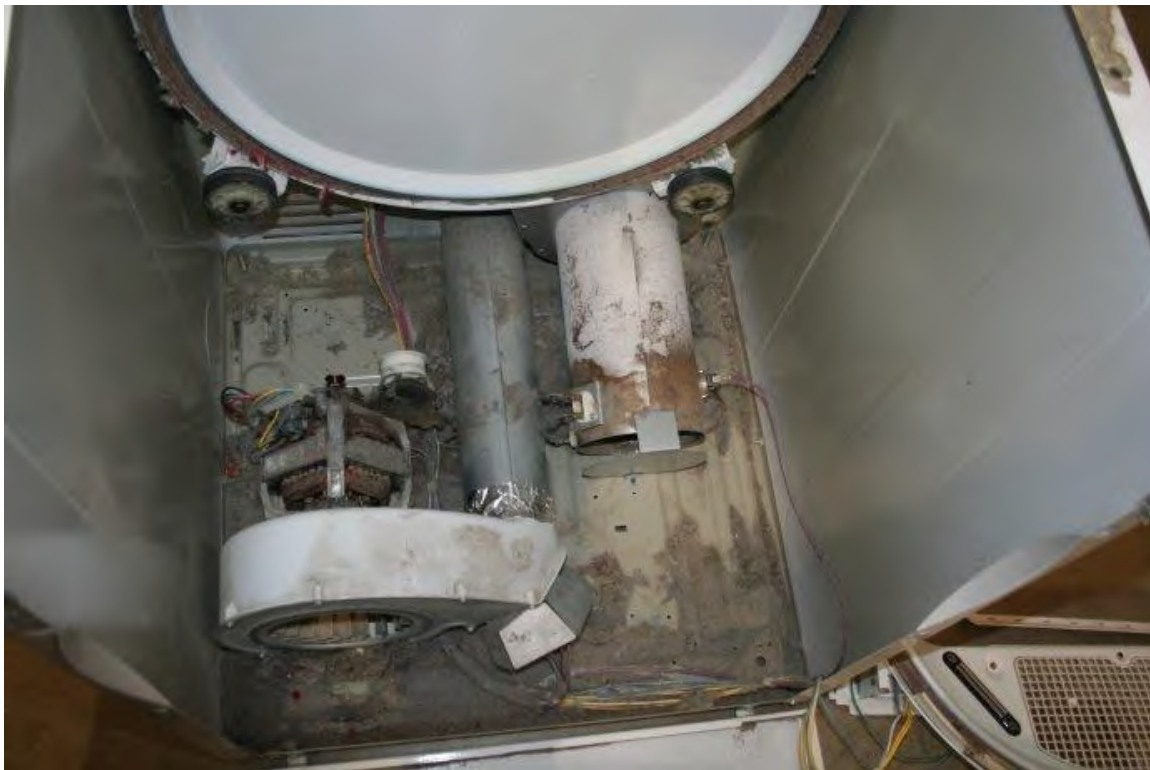
Photo 21: Used Maytag Dryer - Cabinet and Heater after Testing
